REVIEW AND ASSESSMENT OF EXISTING CONDITIONS AT VINEYARD HAVEN PUBLIC LIBRARY

Vineyard Haven Public Library
Vineyard Haven, Massachusetts
Structural Assessment
January 22, 2024

Mechanical, Electrical, Fire Protection and Plumbing Existing Conditions Study for Vineyard Haven Public Library

Existing Building Code Report

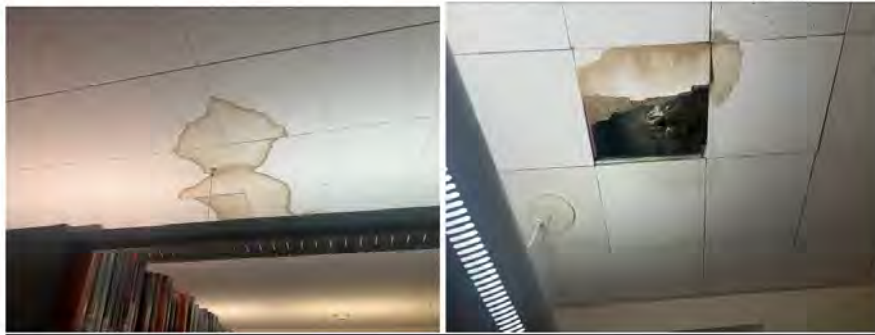
We observed signs of water leaks at some locations in the library, the signs of leaks were observed in the ceilings and from windows and exterior walls. Some of the water stains are probably from condensation of the utilities in the ceiling space.

Water Stains in the upper level ceiling

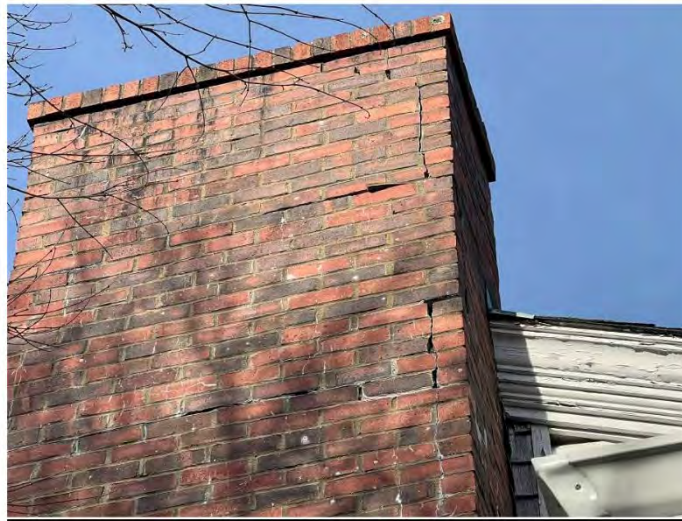
We also observed some deterioration in the exterior wall siding. We observed substantial cracks in the masonry chimney.

Substantial cracks in the masonry chimney

The existing library structure appears to be in fair condition. All of the structural components that are visible appear to be in sound condition except the items noted above. The cracks in the masonry chimney need to be repaired as soon as possible before it manifests in to a structural issue. The ongoing water leaks through the roof and the building envelope is a concern and should be addressed as soon as possible.

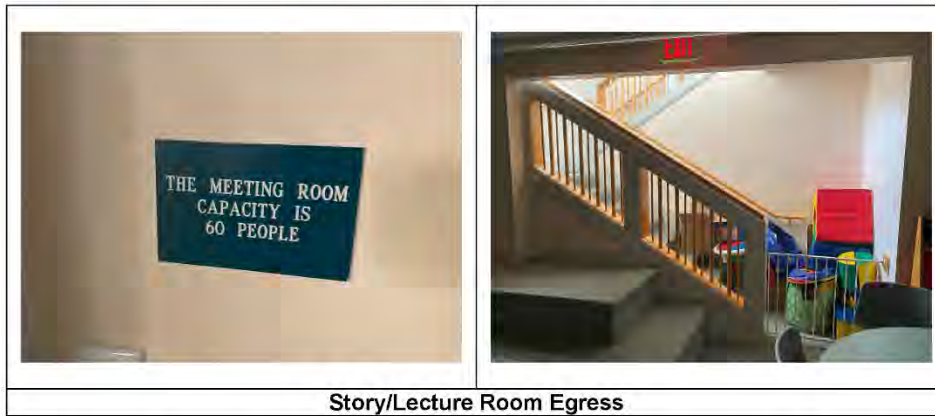
The only hazardous condition noted during the site visit is that the Lower Level Story/Lecture Room has a posted occupancy of 60 people and requires two means of egress. The second means of egress from this room is an open stair to the upper level that is current used for storage and has a child safety gate that both obstruct egress in an emergency. If the room will be used for any events with more than 49 occupants these obstructions must be removed regardless of whether the building is renovated.

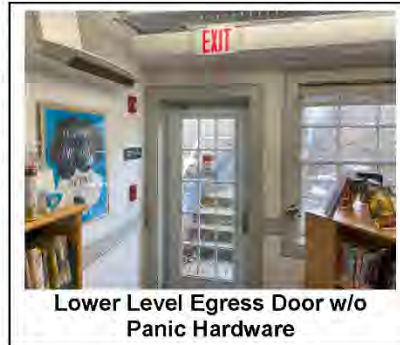
The existing primary egress doors with latches generally include panic hardware as required. The front entrance doors are powered sliding doors that can be pushed open in an emergency as required. However, there is at least one existing exit door (side door from the Young Adult area on the Lower Level) that is not provided with panic hardware.

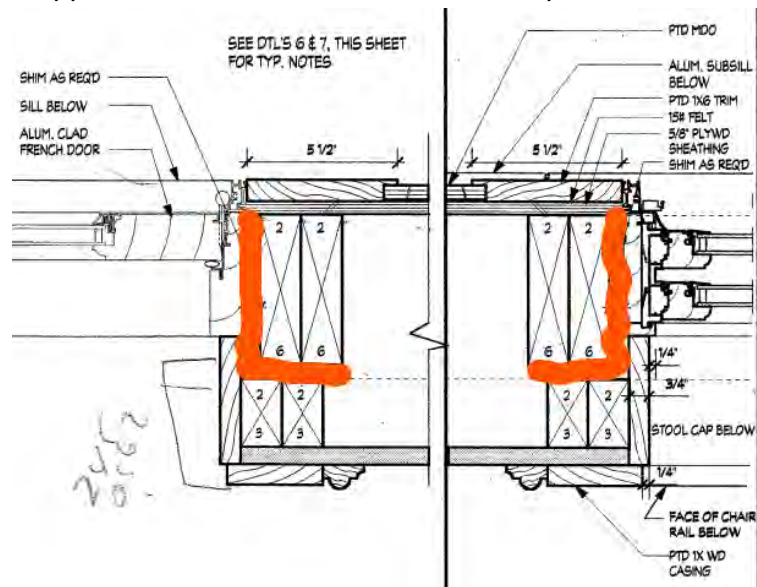
There was quite a lot of microbial growth viewed on many exterior surfaces and Tappe suspects this may be slightly more prevalent in the warmer parts of the year. The image to the right shows where additional foam sealants should be applied as windows and doors are replaced or repaired. These locations are subject to a lot of stress from air and moisture leaks over time.

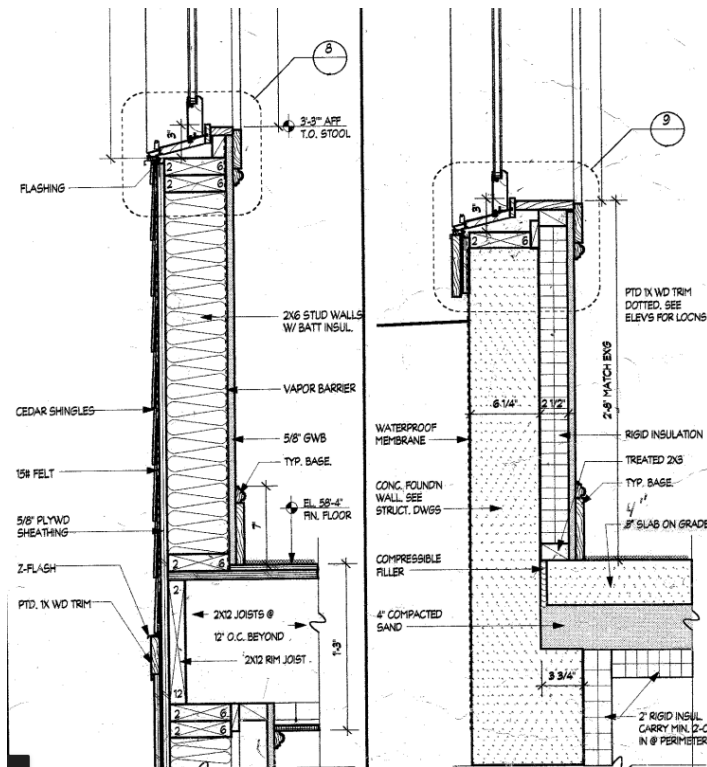
It appears that the library was constructed of dimensional 2x6 lumber and filled solid with batt insulation above grade. Below grade, there is a 6.25" concrete stem/foundation wall which has 2.5" rigid insulation on the interior side.

For the above grade portions this results in an r-value around R-20 when it is new. There will be some loss of that value over time as the insulation settles or becomes wet, etc. The few accessible locations for inspection of the insulation appear to be in fair shape, but with any updated renovation or expansion careful consideration should be given to the whole building. If new insulation becomes a pathway forward it would be prudent to look at closed cell spray foam insulation to provide superior thermal resistance as well as some moisture and vapor mitigation. New building codes and stretch energy codes as well as new standards for energy efficient building techniques would be looking for

insulation in the stud cavity with added continuous insulation on the exterior side of the wall. This is to help address thermal bridging and the de-rating of the thermal performance of the insulation due to the intermittent structural members.

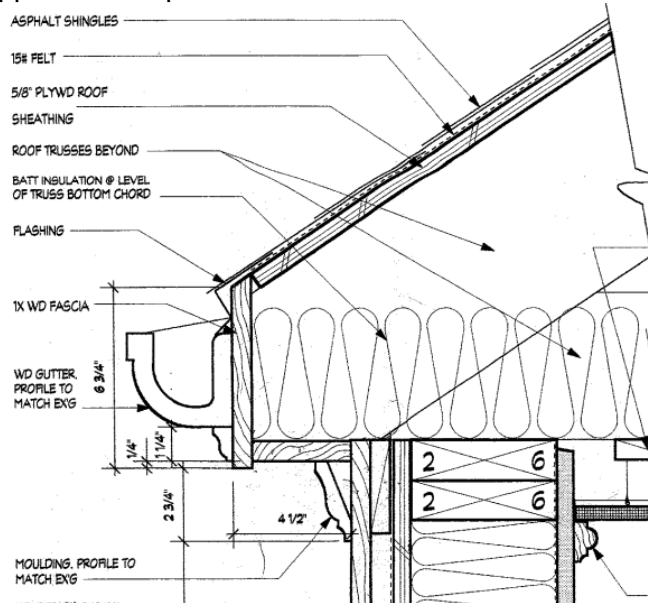
A visual inspection of the roof seems to indicate that the roof is nearing the end of its life span and could use an update and replacement. Tappe did not spend much time on the roof but from the ground we recommend the library consider replacing the roof in whole or in part soon based on observation of shingles. It also appears that there is no insulation directly applied to the underside of the roof framing and sheathing. This allows for extreme heat build-up inside the building which puts pressure on the long-term performance of the roof envelope itself and any mechanical systems that are run in the attic space. It is recommended that any project consider adding insulation within the roof joist pockets for the entire roof area at a minimum. This can be done with batt insulation, but a more robust and long-term solution would be the application of spray foam insulation which forms a better envelope seal and a high R-value of insulation. If a roof replacement project is undertaken there should be consideration of adding continuous insulation to the exterior side of the roof sheathing. This is to resolve any thermal bridging that is currently present through the roof joist.

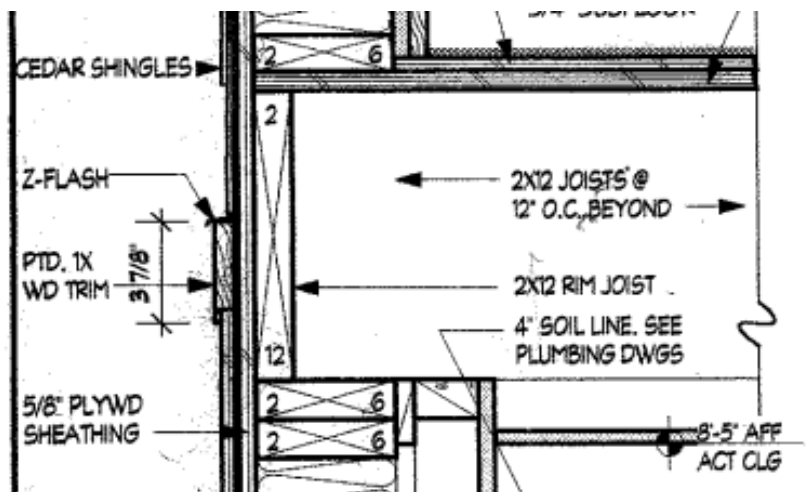
The image below shows what appears to be a typical condition at the floor framing between the lower floor and the upper floor. The joise space appears to lack insulation or it is minimal and intermittent. While this space is speparated by finished ceiling below and finished floor above it still

provides a pathway for thermally connected air leakage in the envelope strategy. While the entire floor joist cavity does not necessarily need to be insulated adding closed cell foam all around these details or even batt unsulation will produce a tighter air seal and possibly mitigate some of the thremal leaks currently

present in the building. A full cavity insulation strategy will help with acoustic separation if there are any concerns with noise traveling between floors.
