REVIEW AND ASSESSMENT OF EXISTING CONDITIONS AT VINEYARD HAVEN PUBLIC LIBRARY

Vineyard Haven Public Library
Vineyard Haven, Massachusetts
Structural Assessment
January 22, 2024

Mechanical, Electrical, Fire Protection and Plumbing Existing Conditions Study for Vineyard Haven Public Library

Existing Building Code Report

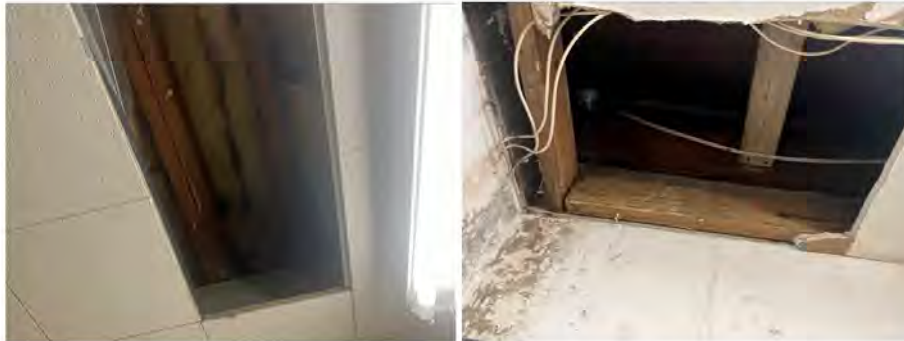
Typical Floor Framing
